# Walk Around

## F-8 Crusader

Walk Around Number 38  
squadron/signal publications

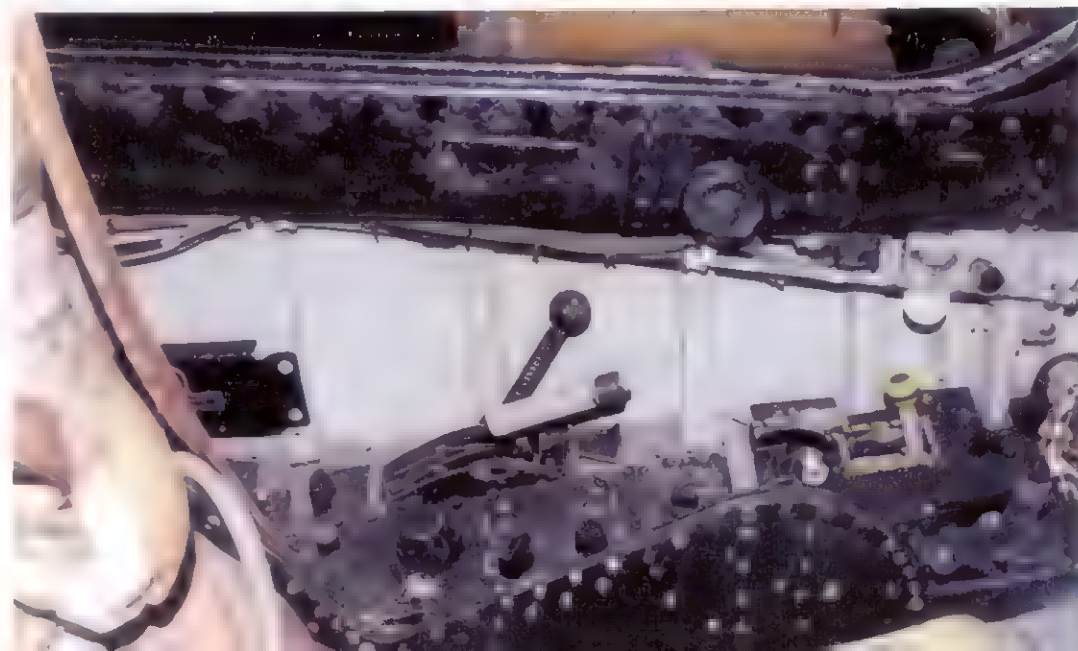
The F8U-1's left console contained (fore to aft): the throttle quadrant, the Yellow knobbed emergency brake handle lever, the fire control master panel, trim controls, radar control panel, oxygen distribution control, speed brake, and cruise droop control switches. A ball is mounted atop the wing lock down handle. The wing incidence control lever is the round handle in front of the lock down lever. (Dann)

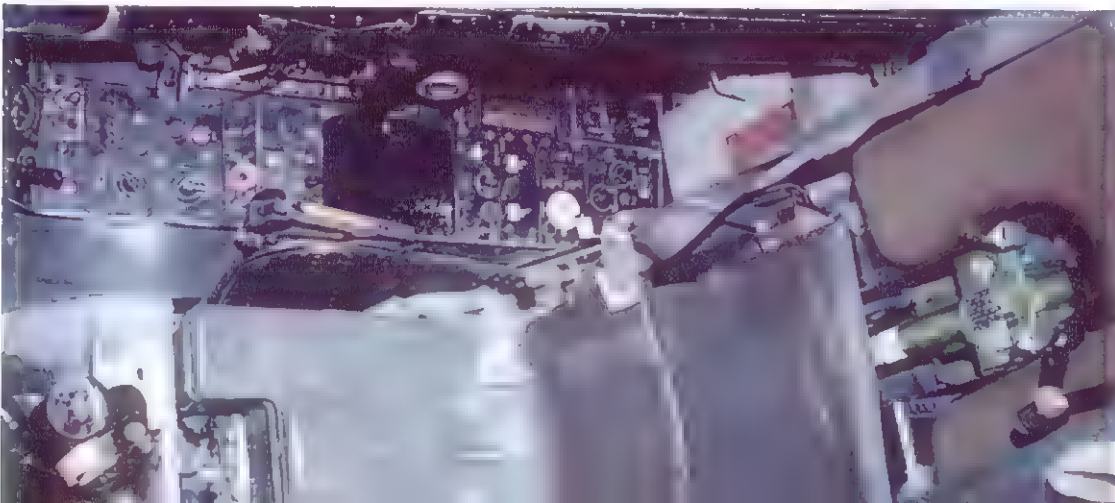
The F-8E's right console followed the same principles as on earlier Crusaders. This console contains (fore to aft): the arresting hook handle, cabin altimeter, electrical distribution control, air conditioning control, autopilot panel, lights, and IFF control panel. Two blank panels housed the Tactical Air Navigation (TACAN) and Ultra High Frequency (UHF) radio controls. The wing fold control is under the Yellow and Black panel at the upper aft end. The chart board light was suspended from the canopy sill just behind the canopy locking handle. (Detail & Scale)

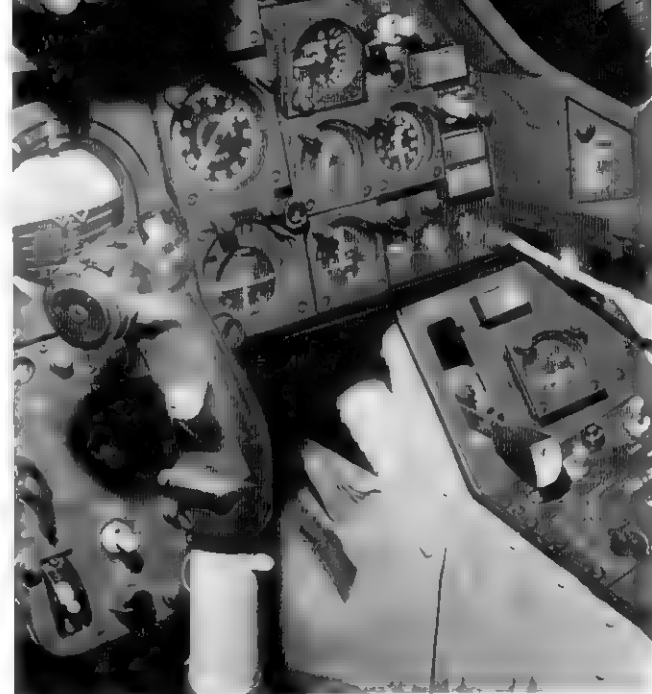
A single grip control stick was installed on earlier F-8U-1 (F-8A) through F8U-2 (F-8C) aircraft. The nose gear steering switch was located on the grip's bottom facing forward. The button in the middle left side of the grip was the stores release switch, while the gun trigger was on the grip's front. The landing gear position lever is located to the left of the rudder pedals. (Vought)

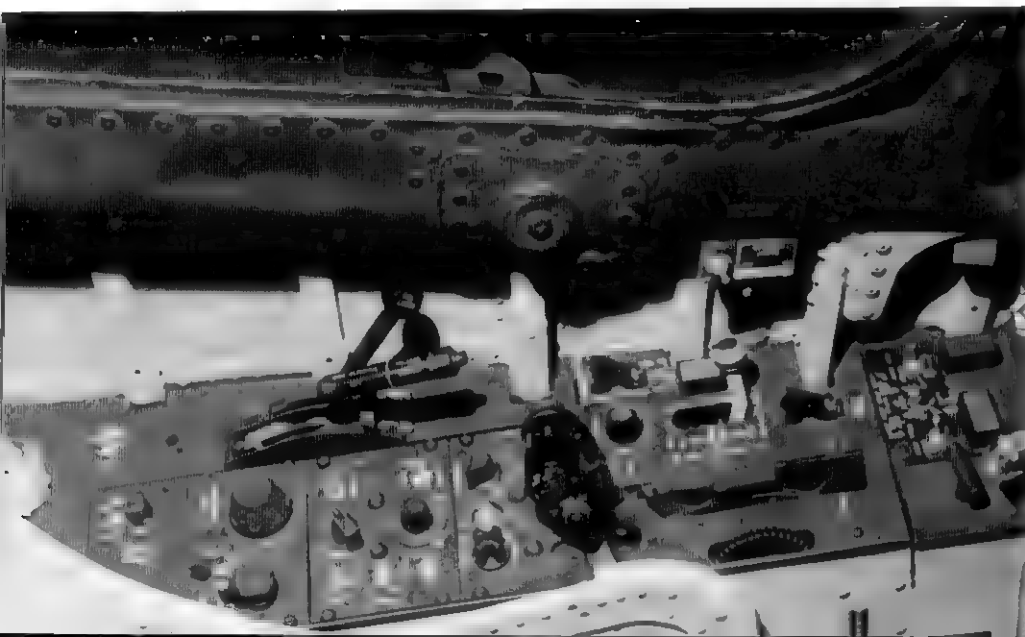
The manual interior canopy release lever was located on the right canopy sill's front area. This lever was moved forward to lock the canopy closed. Detents (locks) allowed the handle to be stowed while in flight. The cockpit emergency ventilation control knob is mounted behind the canopy control lever. This knob allowed the pilot to control the amount of ram airflow into the cockpit. (Vought)

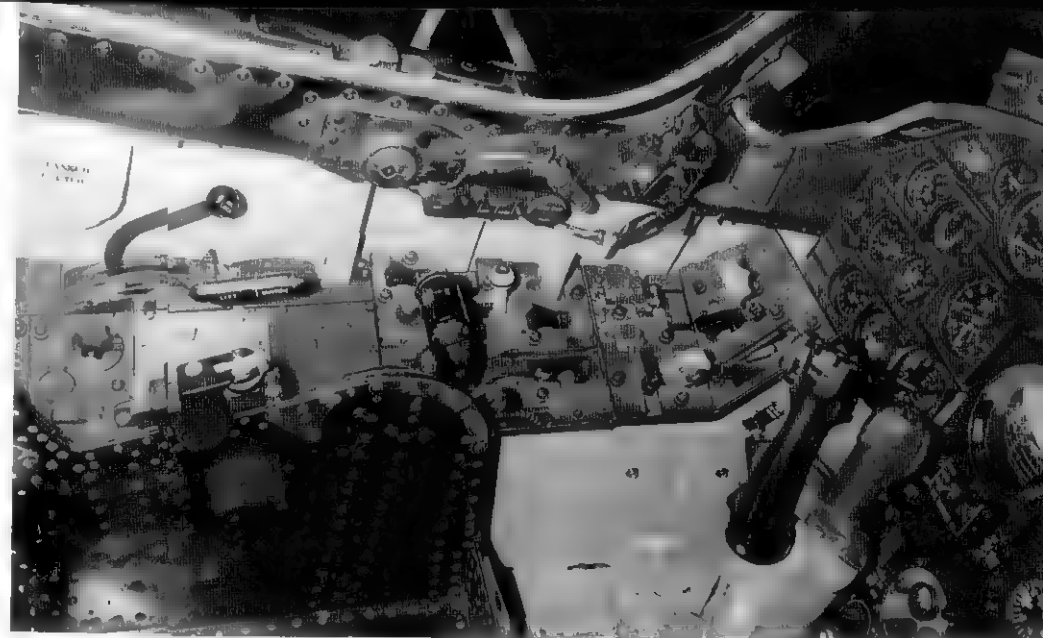
The same F-8D's left console shows little difference from the consoles of earlier Crusaders. The main differences included a reshaped wing lock down handle, which eliminated interference with the wing incidence control handle. A gyro caging switch panel, cabin spotlight, and the approach power compensator panel in front of the parking brake handle were also added in addition to the dual grip control column. (Vought)

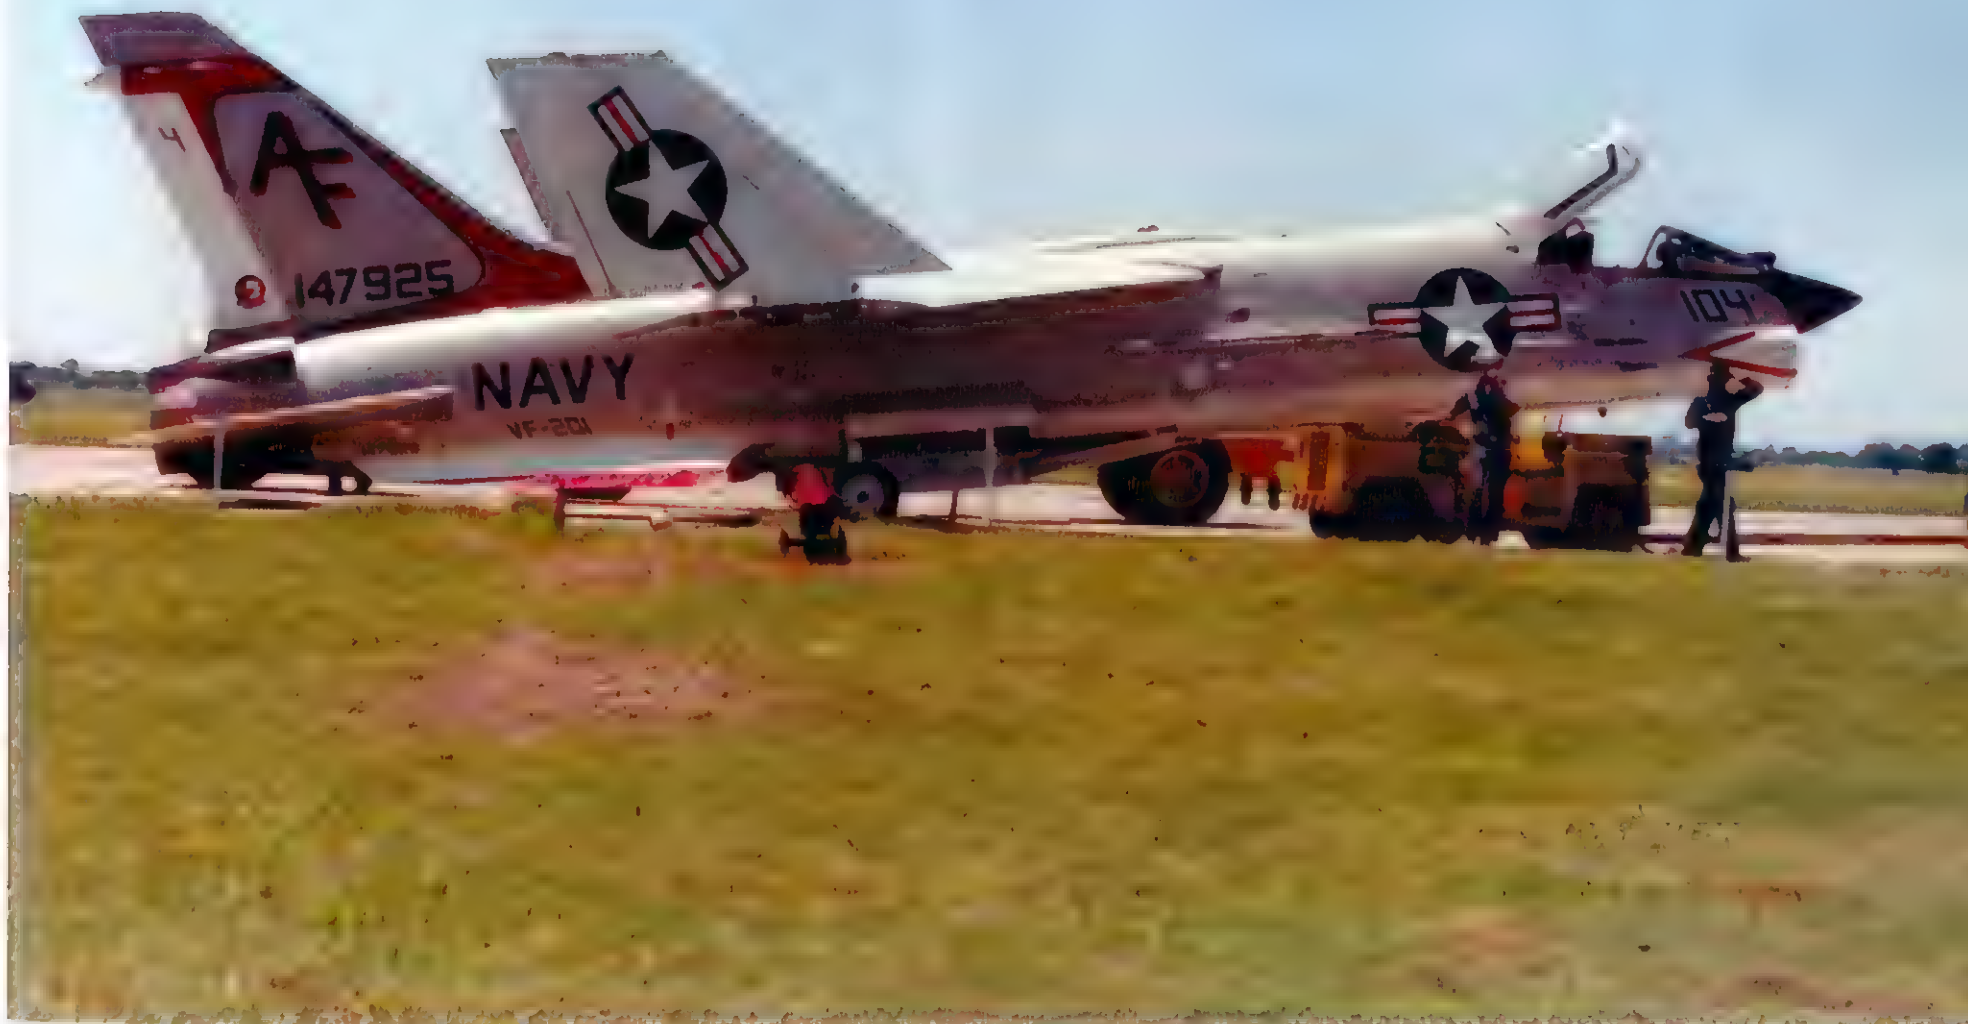
A VF-201 'Red Riders' F-8H (AF-104/BuNo 147925) is parked between missions at NAS Dallas in May of 1975. This variant featured the more powerful J57-P-20 engine, which resulted in the addition of afterburner cooling scoops on the aft fuselage. Wing pylons were not fitted on this Crusader, but provision for them was incorporated during rebuild-

ing of these aircraft. This Naval Reserve squadron flew this Crusader variant between December of 1970 and February of 1976. VF-201 previously flew the F-8K (remanufactured F-8C) from July of 1970. The AF tailcode indicated Reserve Carrier Air Wing Twenty (CVWR-20), the Atlantic Fleet's Reserve Carrier Air Wing. (USMC via Alexander)

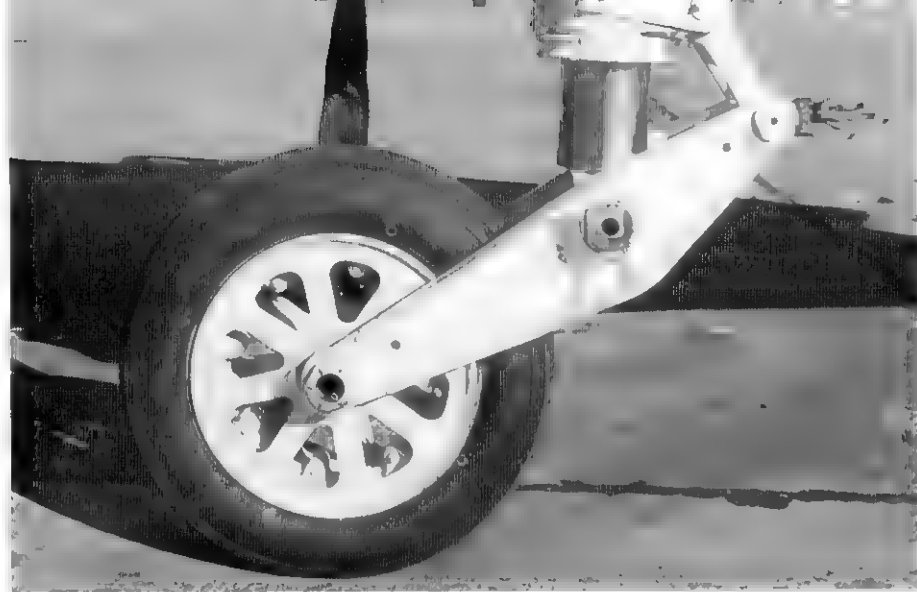
F8U-1 (F-8A) to F8U-2 (F-8C) and F8U-1P (RF-8A) Crusaders employed a spoked-style nose wheel. The nose gear was capable of full 360° caster when the nose gear steering system was not engaged. The early style nose gear had main support yoke arms that terminated at the front torque linkage. The 16-ply tubeless nose gear tire was 22 inches (559mm) in diameter by 5.5 inches (140mm) wide. (Vought)

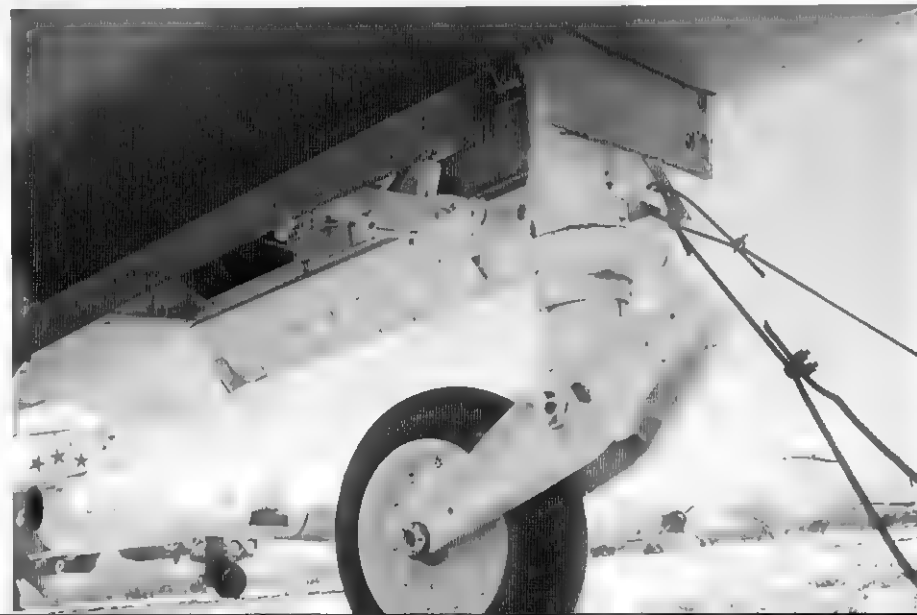
The second style nose wheel was introduced on the F8U-2N (F-8D) variant. It was made of a solid aluminum casting that replaced the earlier spoked design. This solid style wheel replaced the spoked wheel on earlier Crusaders as they were processed through routine maintenance. A mooring tie down loop was located at the main gear shock strut's front section. (Rough)

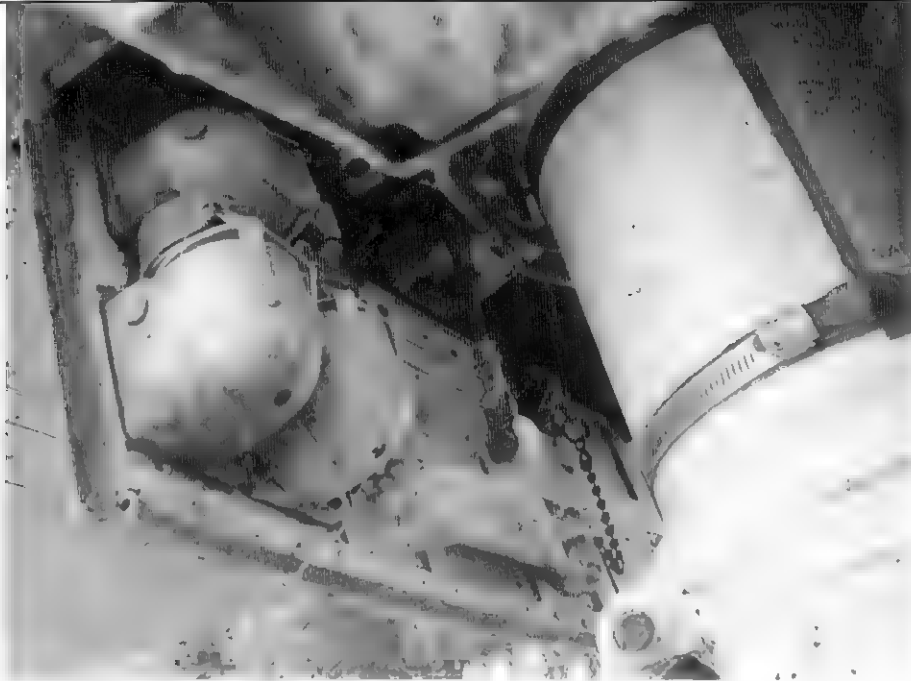
The nose flipper door was a single piece of aluminum, with a reinforcing frame riveted to the main plate. Three approach indicator lights were housed in watertight sockets fastened to the main door panel. The door was connected to the nose gear torque tube by a connecting rod at the door's center. This door closed during landing gear retraction. A rubber lip seal was installed on the door's lower edge. (Lubin)

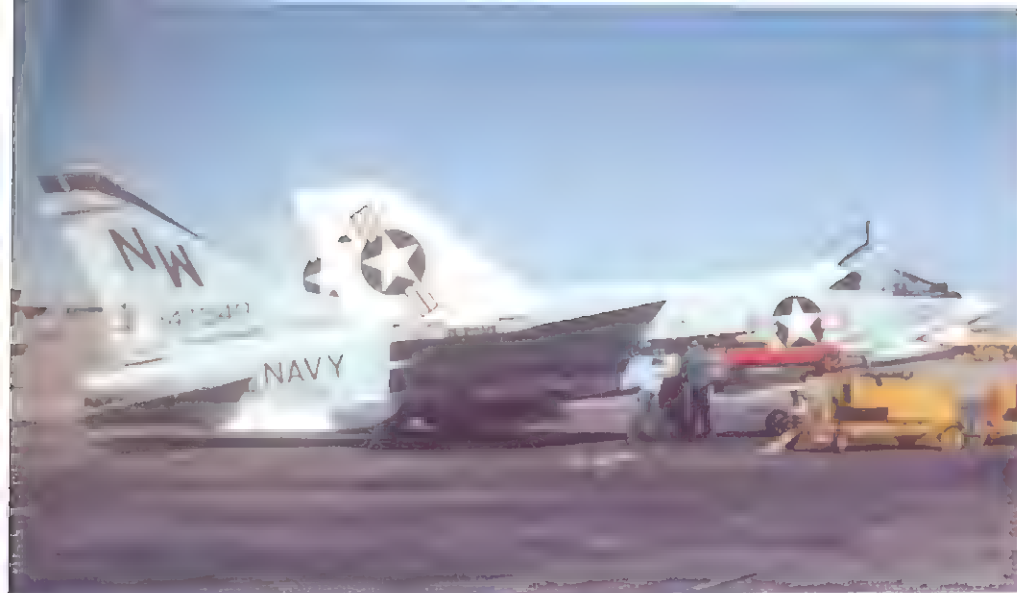
Maintenance technicians test the Emergency Power Pack (EPP) on this F-8H (NW-601/BuNo 147049) of Anti-submarine Fighter Squadron Eighty Six (VSF-86) 'Gators' prior to a mission. This Squadron provided fighter protection for anti-submarine aircraft carriers. The F-8H was a remanufactured F-8D, which featured an upgraded wing with a higher load design. Other changes included improved landing gears and arresting hook, wing mounted external stores capability, a larger AN/APX-94 radar scope, and a pneumatic gun charging system. (JEM)

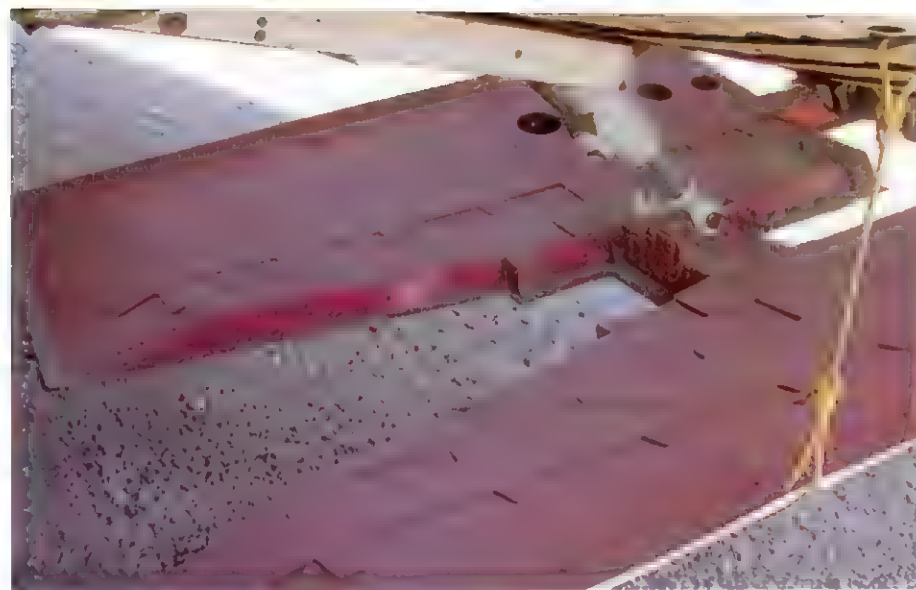
The speed brake was an integral part of the rocket pack installation on F8U-1 (F-8A) through F8U-2 (F-8C) aircraft. A hydraulic cylinder opened this brake, which retracted into the rocket pack's bottom. This speed brake was extended up to 59". The speed brake actuation circuit was interlocked with the main landing gear to prevent opening during ground operation. (Rouch)

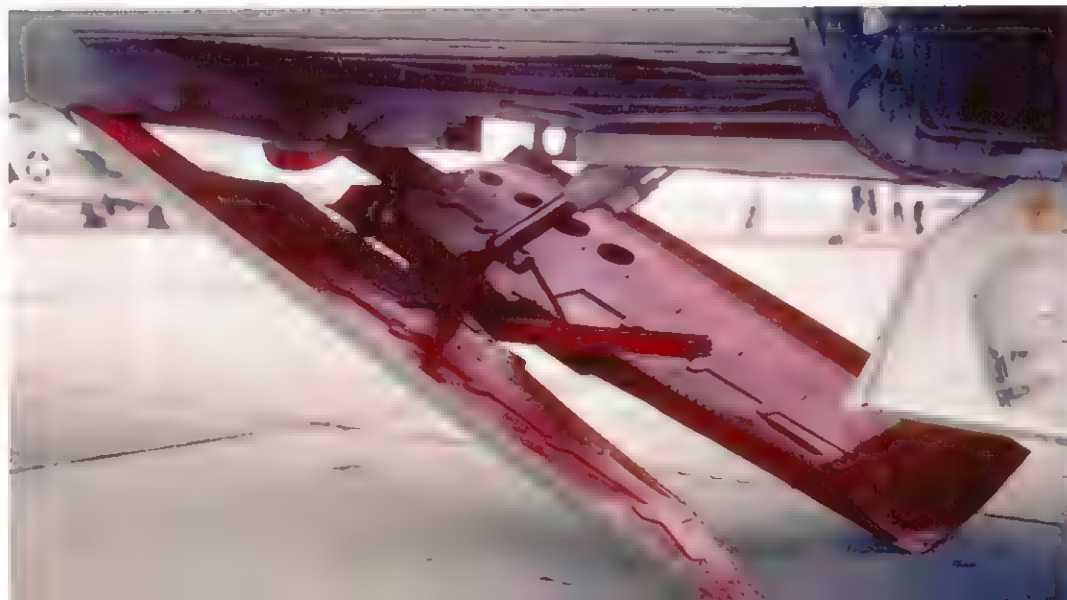
Eliminating the rocket pack provided additional space in the lower fuselage section. F-8s with the upgraded landing gear had the Power Control (PC) system's accumulator function moved from the landing gear tension strut to a separate reservoir cylinder in the speed brake well. This is the left speed brake well looking forward. (Weinel)

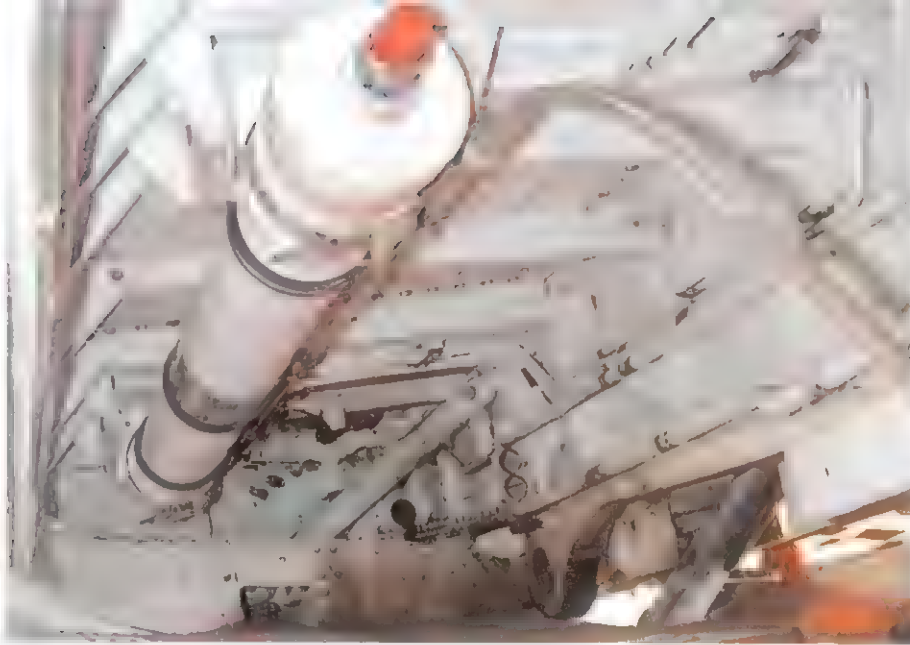
The bulkhead at fuselage station 424 functioned as both the speed brake well's aft bulkhead and the landing gear well's front bulkhead. A rubber rib seal located on the fuselage interface prevented air from entering the speed brake well at high speed. This is the left speed brake well looking aft. (Lubin)

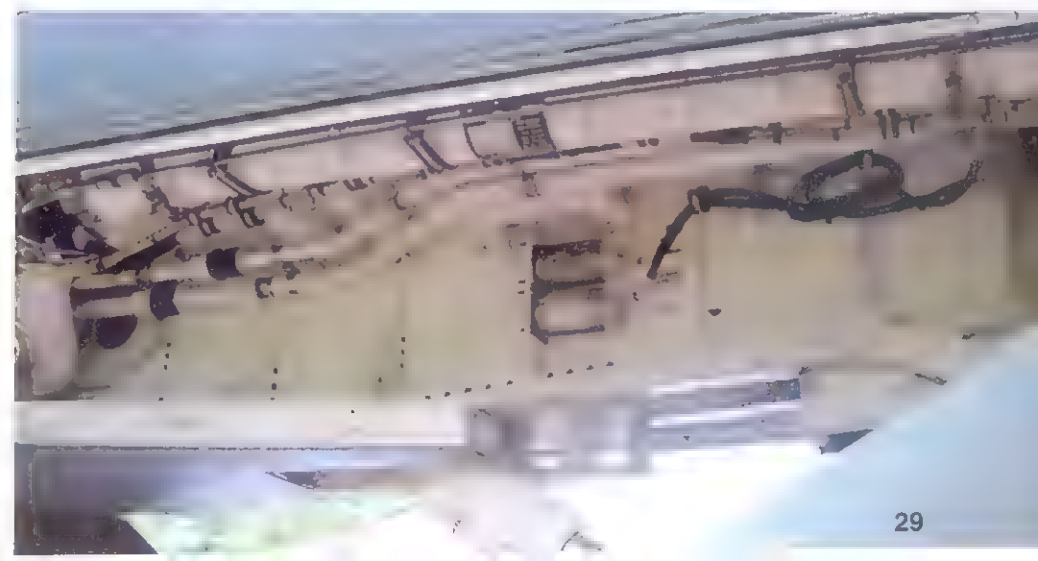
The speed brake was operated by utility hydraulic power and could be fully or partially extended. This speed brake actuating cylinder was mounted to the fuselage keel by a hinge. This allowed the cylinder to travel in an arc as the speed brake opened or closed. A flipper plate attached to the speed brake covered the cylinder when the brake was fully retracted. (Lubin)

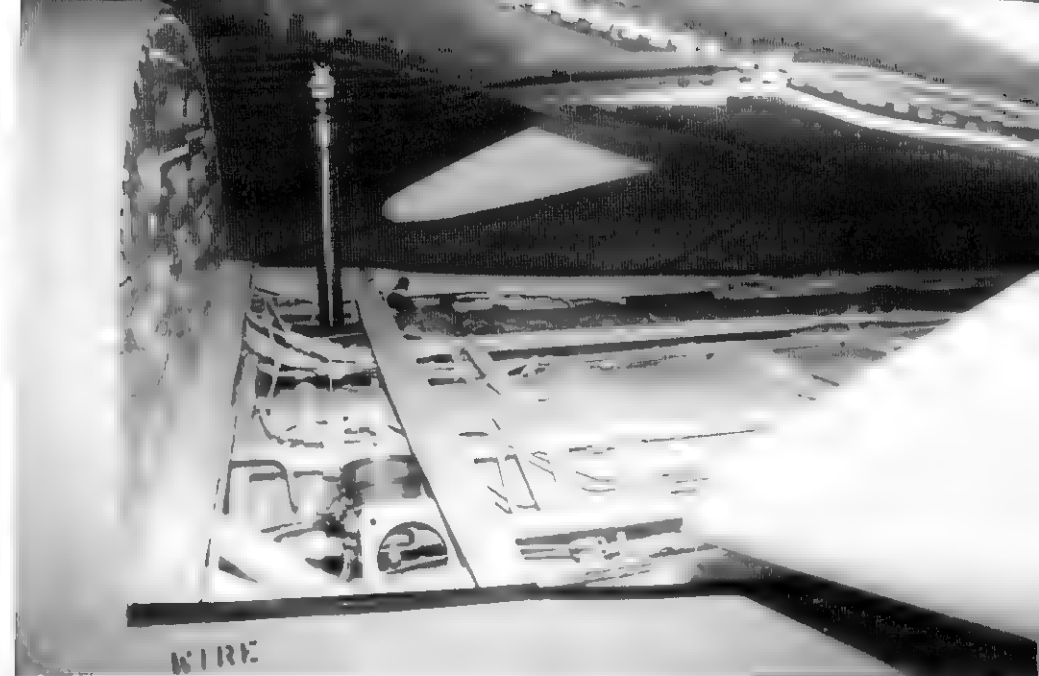
The wing box's formed aluminum front bulkhead was riveted to fuselage ribs and had reinforcing dimples for rigidity. A rubber seal was located on the fuselage skin edge, which sealed on the wing assembly's bottom face. (Author)

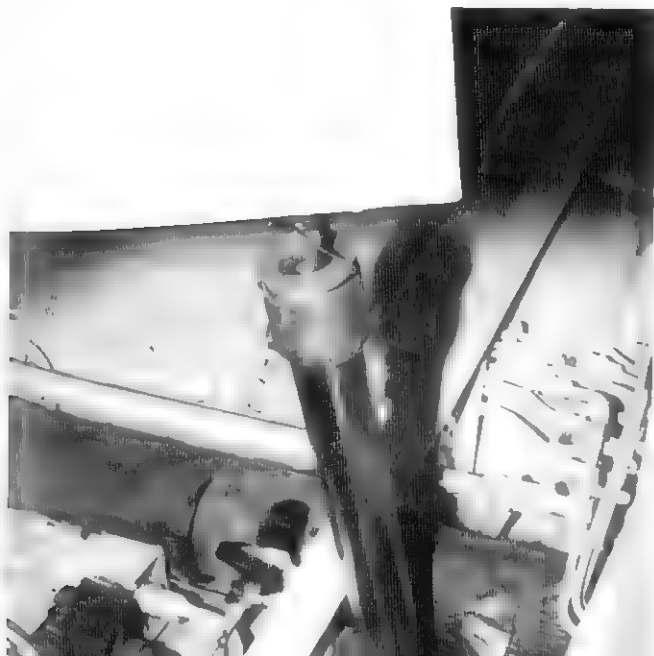
The wing elevation hydraulic cylinder was fastened to the fuselage structure by a hinge at the cylinder's lower end. This allowed the cylinder to accommodate the arc created by the wing's travel when raised. The cylinder had a 3.5-inch (8.9 cm) diameter rod and a stroke of 17.5 inches (44.5 cm). The cylinder assembly's overall height was 34 inches (86.4 cm) and it weighed 30 pounds (13.6 kg). (Author)

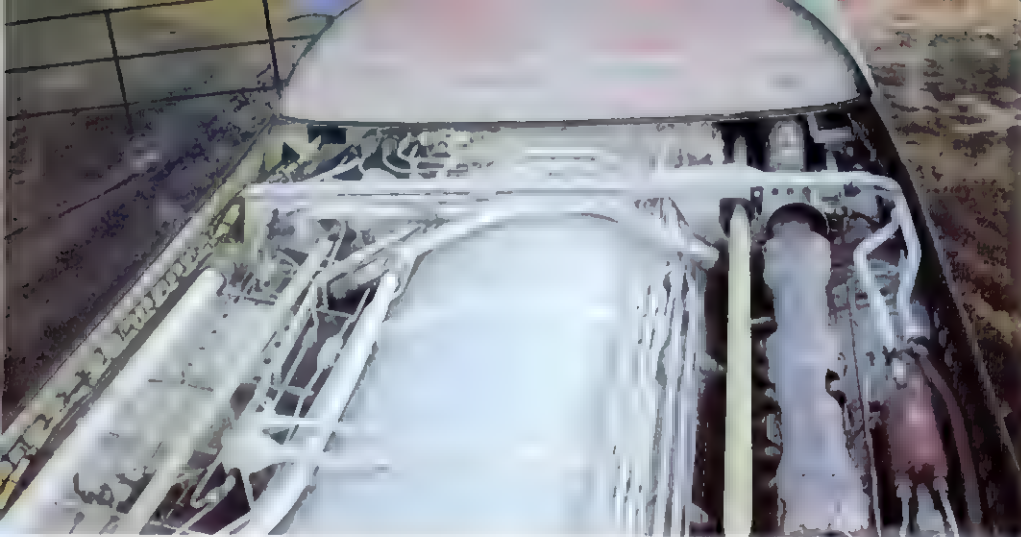
The engine air intake duct located on the aircraft centerline is exposed with the wing removed. An insulated heat exchanger cooling line and the cylindrical Red fuel filter are located to the right. Larger diameter white tubes are fuel transfer lines, while smaller diameter tubing consisted of hydraulic and pneumatic system lines. Wire bundles ran along the outer edges of both sides. Flight control system push rods and cables were also located in this area. (Weinel)

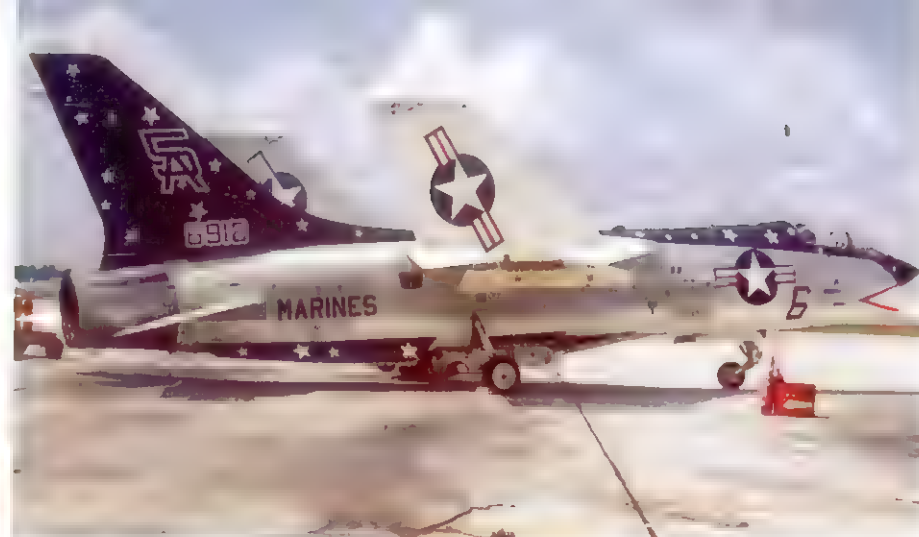
An F-8K (5A-6/BuNo 146918) of VMF-321 sits on the ramp at Andrews AFB, Maryland in September of 1971. This Crusader was an F-8C remanufactured to F-8K standard. The main areas addressed by this rebuild were incorporating an improved wing with extended fatigue life, an improved nose landing gear, a change to the F-8E-style main landing gear, fuselage strengthening, and an improved arresting hook shank. (JEM)

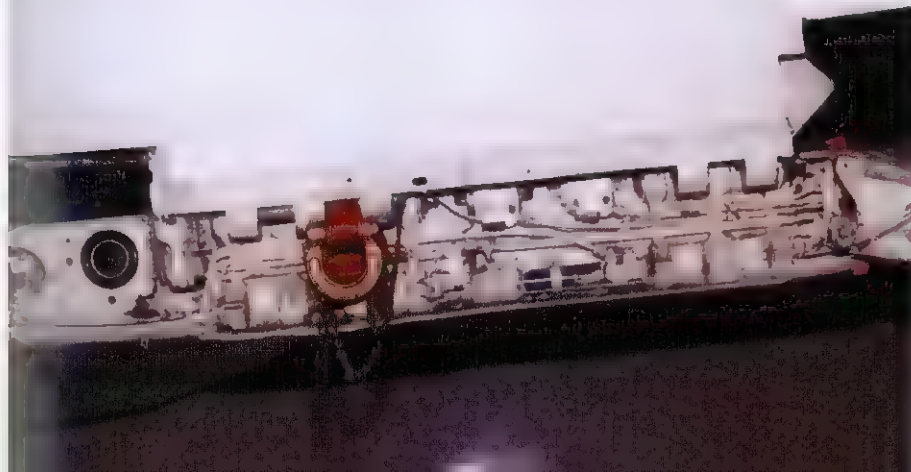
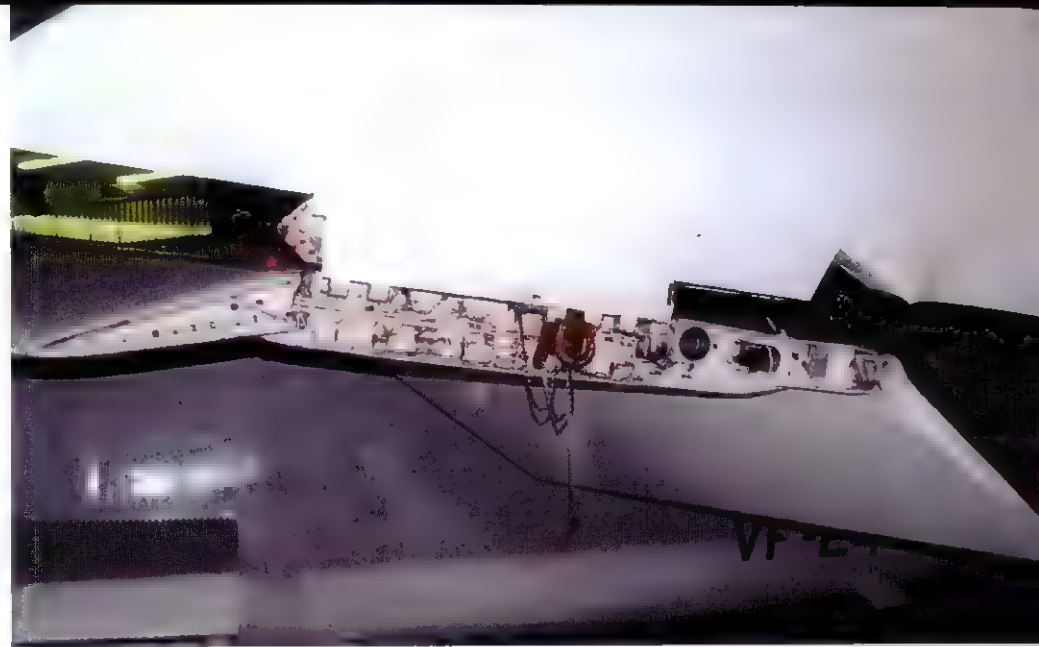
The F-8's outer wing panels folded upward at a 90° angle for storage. This reduced the wingspan from 35 feet 8 inches (10.9 m) to 22 feet 6 inches (6.9 m). The wing fold and hinge mechanism was the same on both right and left wings. No control surfaces were located on the outer wing panels, which eliminated the need for complex mechanisms. (Dann)

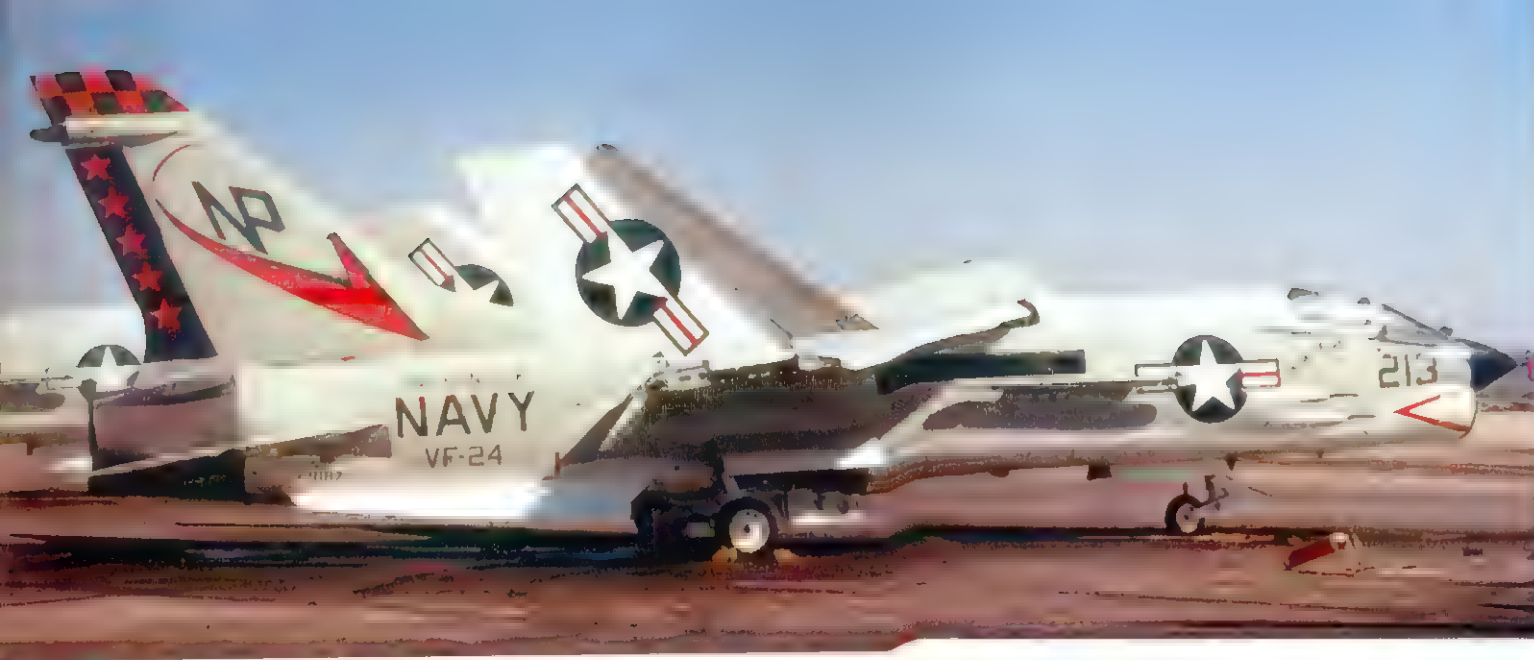
F-8E (FN)s and F-8Js were equipped with a full span leading edge double droop to increase wing camber (surface curvature) and effectively decrease landing speed. The double droop basically split the one-piece droop of earlier variants into two sections along the entire wingspan. Six hydraulic cylinders – three on each wing – actuated the leading edge droops. Two cylinders operated the inboard section droop and one cylinder operated the outer wing panel droop. This F-8J (NP-213/BuNo 149187) was assigned to VF-24 aboard USS HANCOCK (CVA-19) during the early 1970s. (JEM)

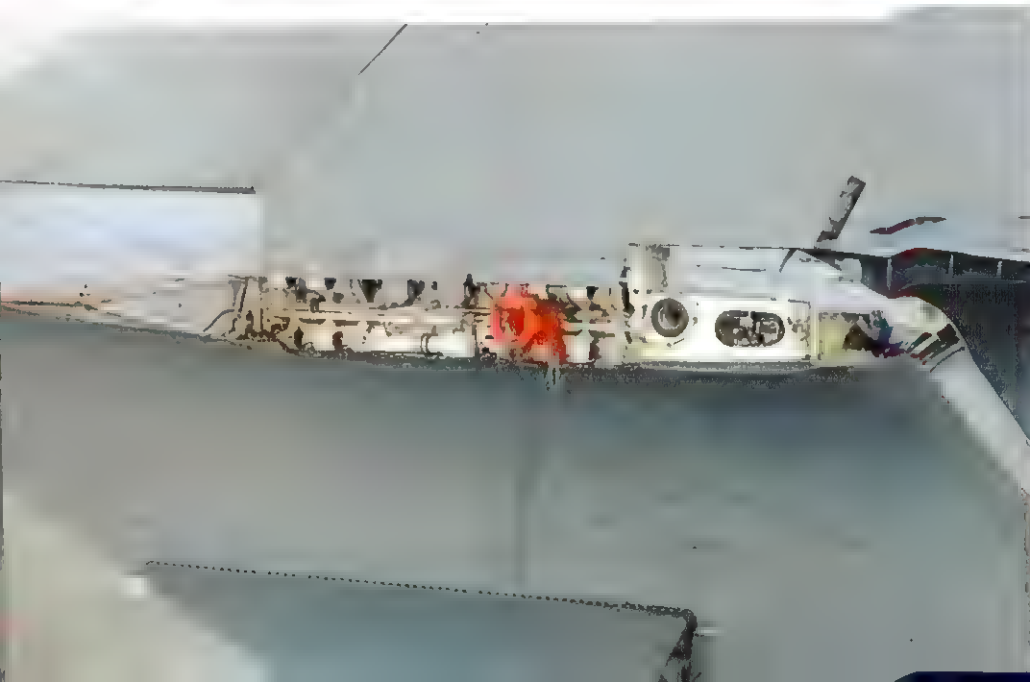
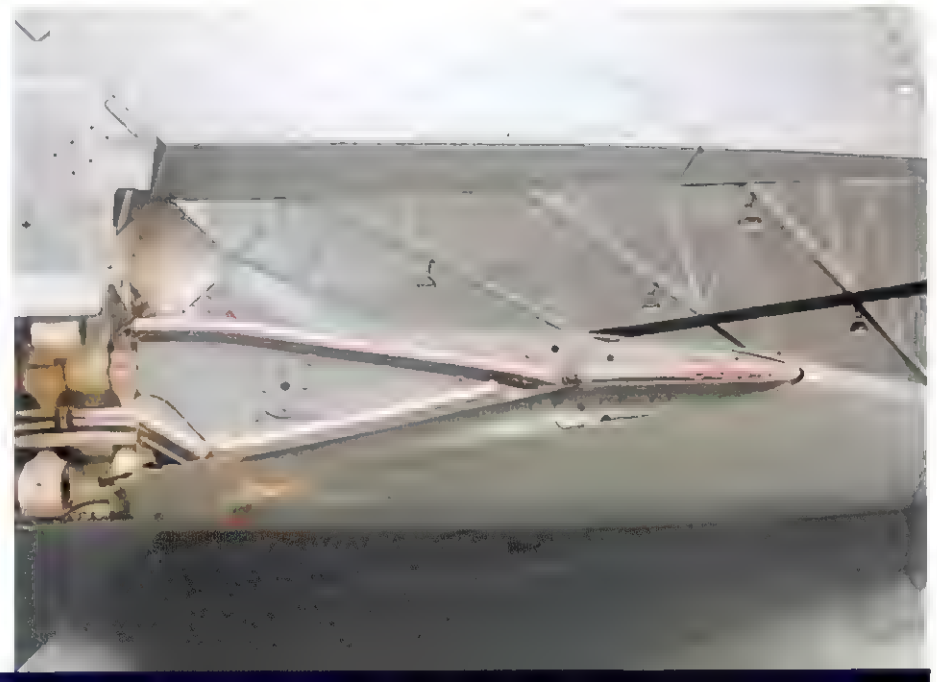
The double droop wing's folding mechanism was identical to the single droop wing's mechanism. Both the forward droop and aft aileron were hinged at the lower surface to provide efficient operation. Outer wing surfaces hydraulically folded up and slightly inboard. (Wrobel)

The inboard section's forward segment drooped 36.9° and the aft segment drooped 7.3°. The forward segment of the outer panel drooped 55° and the aft segment drooped 20°. The static seal between the outer section and outer panel droops was also redesigned from those on single droop wings. (Weinel)

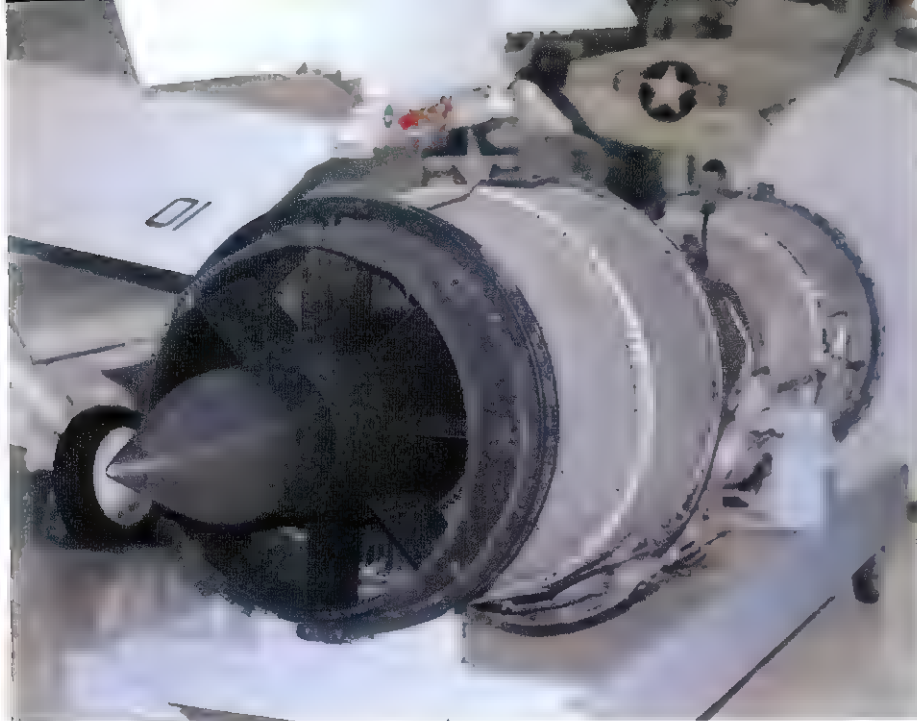
Pratt & Whitney J57 series turbojet engines powered the Crusader family. The J57 was a two-spool, axial flow, chamber combustion turbojet with afterburner for thrust augmentation. The engine's nominal dimensions were 22 feet 6 inches (6.9 m) in length by 42 inches (106.7 cm) in diameter. Afterburning thrust ratings varied from 16,000 pounds on the F-8A's J57-P-4 to 18,000 pounds on the F-8D/E's J57-P-20. (Nick)

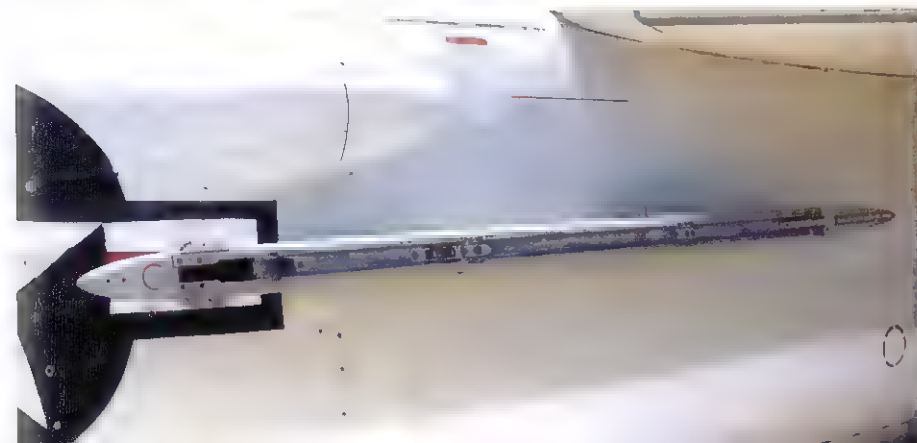
The LAU-7 launcher rail was carried on each fuselage side above and aft of the gun bays and forward and below the wing leading edge. The rail's front contained the fin retainer spring clips, while the center section had the store hold down detent (lock) mechanism for securing the item onto the rail. The aft end enclosed a 1.6 gallon (6 L) nitrogen storage bottle for cooling the Infrared (IR) seekers of AIM-9D Sidewinder Air-to-Air Missiles (AAMs). (Dann)

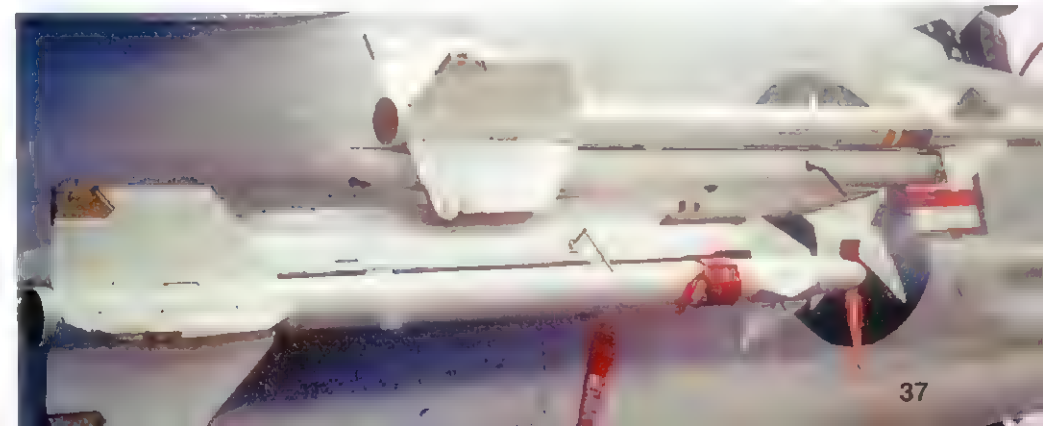
Two Philco (now Ford Aerospace) AIM-9 Sidewinder AAMs were mounted on the dual rail 'Y' adapter. This adapter required using an LAU-7 rail for each missile. An AIM-9C radar-guided missile is mounted above an AIM-9D IR guided missile. Mixed loads of radar and IR-homing AIM-9s were common early in the Sidewinder's career. The AIM-9 was 9 feet 5 inches (2.9 m) long, 5 inches (12.7 cm) in diameter, and weighed 190 pounds (86.2 kg). (US Navy)

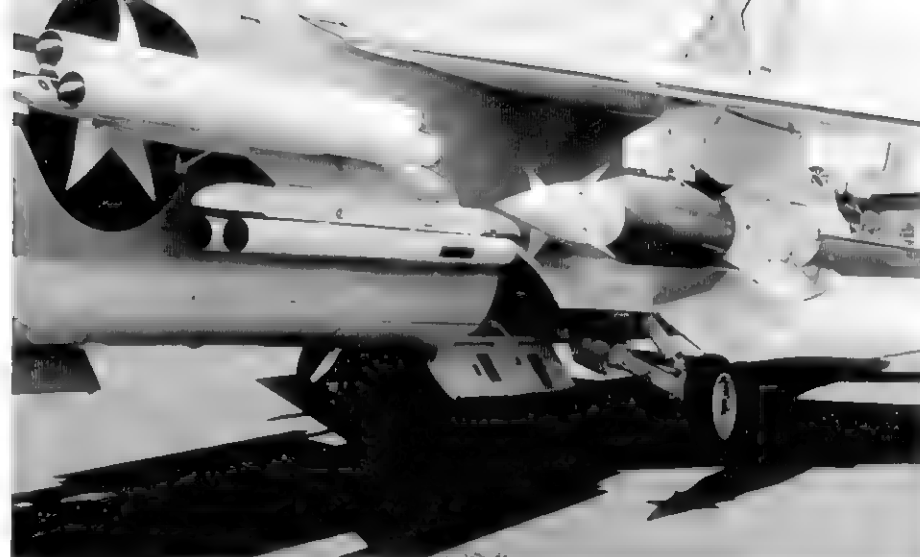
The F-8E was designed to carry Martin/Maxon AGM-12B Bullpup Air-to-Surface Missiles (ASMs) on the wing pylons. A fairing installed above the wing center section accommodated the required system controls. The Bullpup proved ineffective in service and Crusader squadrons never used it on operations. Four 5-inch (12.7 cm) Zuni FFARs are mounted on the fuselage 'cheek' pylons. (Vought)

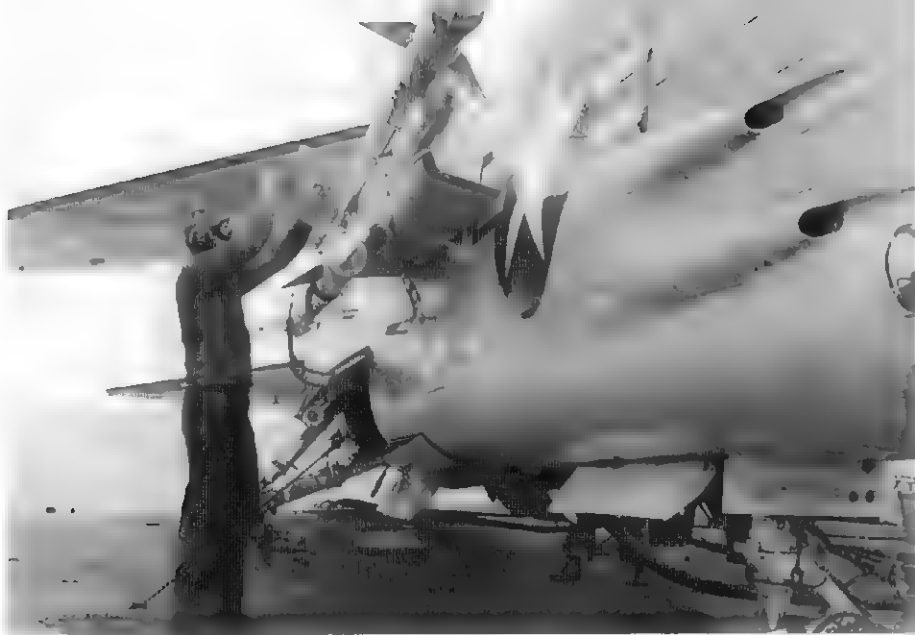
The 'Y' adapter on the F-8's right side had its upper arm extended outward and upward at a 75° angle. The lower arm extended away and downward from the fuselage at a 45° angle. A support brace was located under the 'Y' adapter's center leg between the adapter and the fuselage. (US Navy)

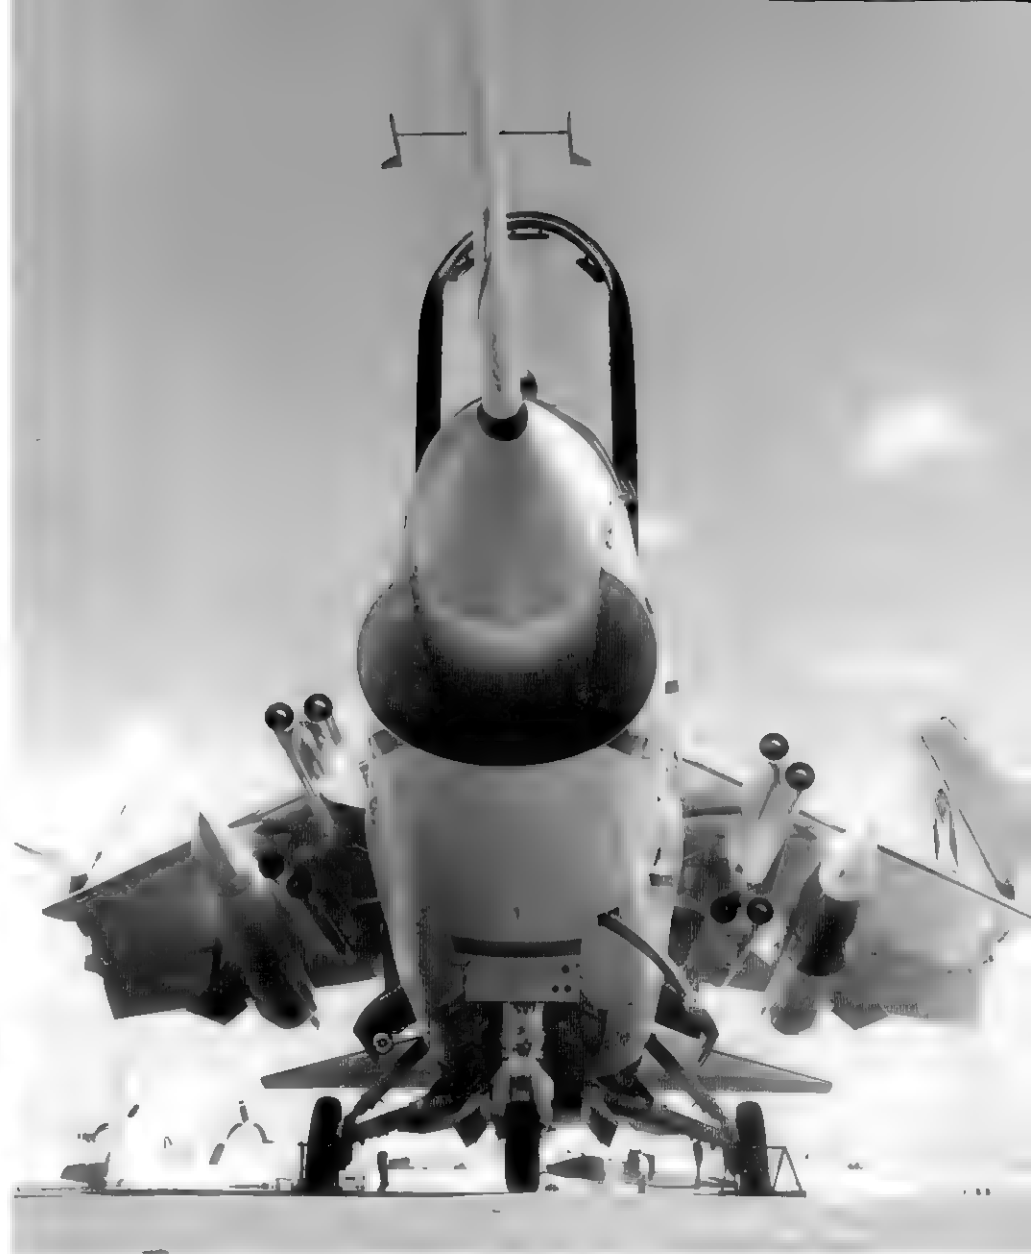
The 'Y' adapter on the left side differed from the right side adapter. The upper arm on the left side adapter did not curve upward. It extended outward at a 45° angle to provide clearance for the extended in-flight refueling probe. In this configuration, the lower Zuni tube was parallel to the ground and the upper tube was at a 45° angle. A support brace also connected the left 'Y' adapter's center leg to the fuselage. This Crusader is fitted with a nose boom for collecting data during test flights. It was not installed on standard F-8s. (Vought)
